## **C-5 A FUSELAGE STRESS ANALYSIS**

**Report No. TR-92-7**

**June 1992**

6. AUTHOR(S) Jatin C. Parekh Warren C. Gibson				
7. PERFORMING ORGANIZATION NAME(S) AND ADDRESS(ES) CSA Engineering, Inc. 2850 W. Bayshore Road Palo Alto, CA 94303			8. PERFORMING ORGANIZATION REPORT NUMBER ASIAC-TR-92-7

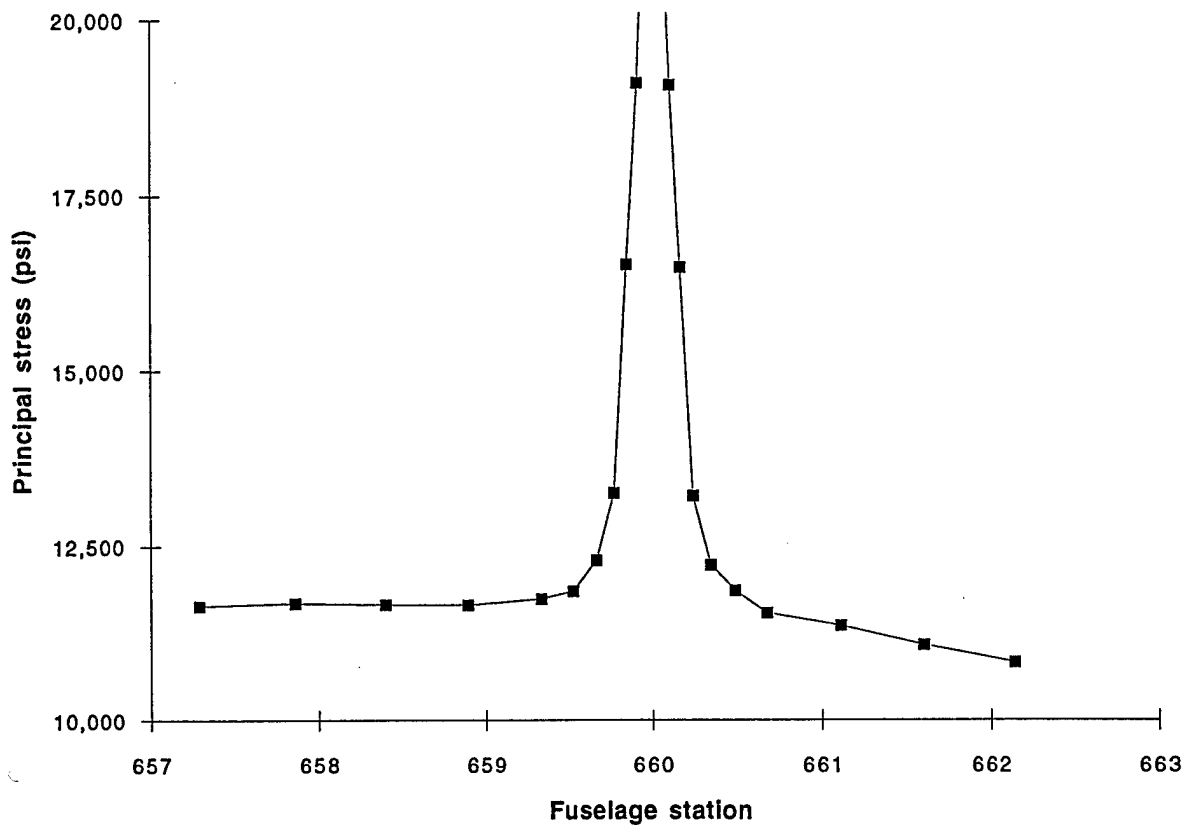
Figure 2: Maximum principal stress along WL 295 near a typical fastener at FS660

**Internal pressure:** The results from the baseline static stress analysis with only uniform internal pressure were as expected. In particular, the stress level in the fuselage skin panel in the hoop or circumferential direction remote from the fastener hole ranged from 10,000 to 12,000 psi. The theoretical value of the hoop stress in a thin-walled cylinder of 143" radius and 0.068" thickness when subjected to uniform radial pressure of 8.3 psi is 17,454 psi. Evidently, the frames and titanium doublers are picking up significant amount of load. The theoretical value of the meridional stress for an equivalent thin-walled cylinder is 8,727 psi; in the fuselage skin remote from the hole, meridional stresses ranged from 6,500 to 7,500 psi; the rest, apparently, is carried by the stringers. The major principal stress near the fastener hole was 19,100 psi, a jump of 75% from the stress observed in the areas remote to the fastener hole. Figure 2 shows a plot of the maximum principal stress along WL 295 near a typical fastener, which in this case was modeled at FS660.

**Internal pressure with cargo load:** When the cargo load is present, the major principal stress near the fastener hole increases from 19,100 psi to 19,860 psi and the location of the point where the maximum occurs shifts by 30 degrees from the horizontal. Additionally, as expected, the stresses in the fuselage skin near the cargo floor are high. Overall, the presence of cargo load influences the WL295 stresses only

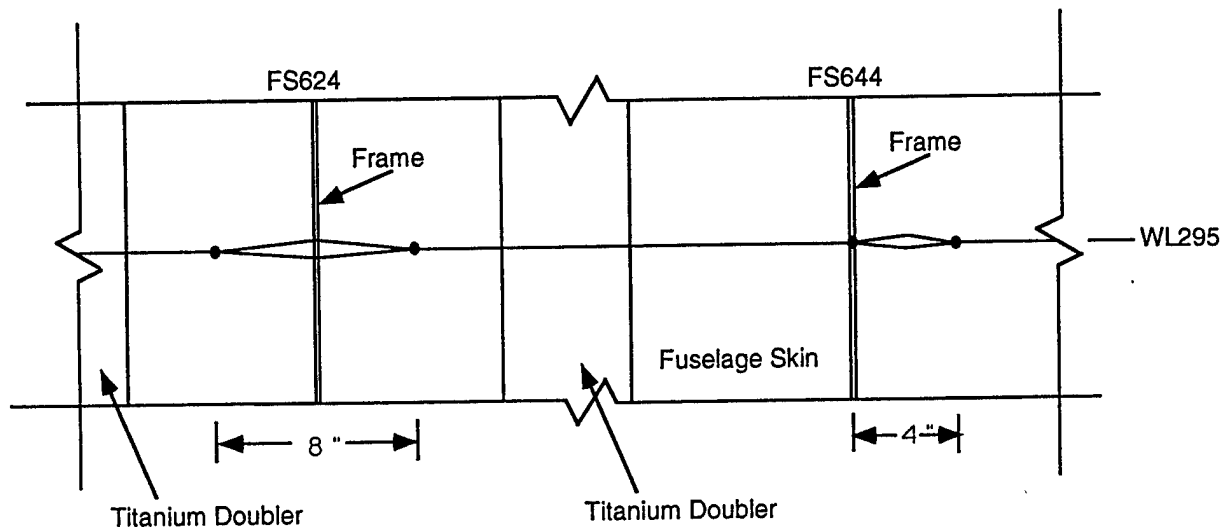
Figure 3: Cracks at WL 295; first crack pattern

Figure 3 shows the crack pattern along WL295 that was used to assess the effects of typical cracks on frames. Specifically, three cracks were modeled: one 8" crack along WL295 centered at FS624 was modeled to determine its effect on the frame at FS624; one 4" crack was modeled from FS644 to FS648 to obtain its effects on the FS644 frame; and one 0.14" crack was modeled at the fastener hole to determine the stresses in the fuselage skin ahead of the crack when a crack initiates and propagates from the fastener hole along WL295.

**Internal pressure:** For the internal pressure load only, the principal stress ahead of the crack near the fastener hole was 15,770 psi; the stress at the same location for the baseline analysis was 13,210 psi, a jump of 20%. Also, the maximum principal stress at the fore edge of the fastener hole increased from 19,100 psi to 20,430 psi. Table 2 shows the forces in the frames under various conditions. Note that an 8" crack causes the bending moment in the FS624 frame at WL295 to increase from 7,503 in-lb to 15,713 in-lb, or 109%. The axial force increases from 5,350 lb to 8,092 lb, or 51%. The 4" crack near the frame at FS644 increases the bending moment by 57% and the axial force by 11%.

**Internal pressure with cargo load:** The maximum principal stress at the fore edge of the fastener hole, for this load case, rose from 20,380 psi to 21,530 psi; the principal stress at the aft edge dropped from 19,860 psi to 15,490, however. Table 2 shows the forces in the frames when the cargo load is present. The presence of an 8" crack caused the bending moment in the FS624 frame at WL295 to increase from 4,893 in-lb to 12,417 in-lb, an increase of 154%. The axial force increased from 5,618 lb to 8,200 lb, an increase of 46%. The forces in the FS644 frame did not change significantly, however.

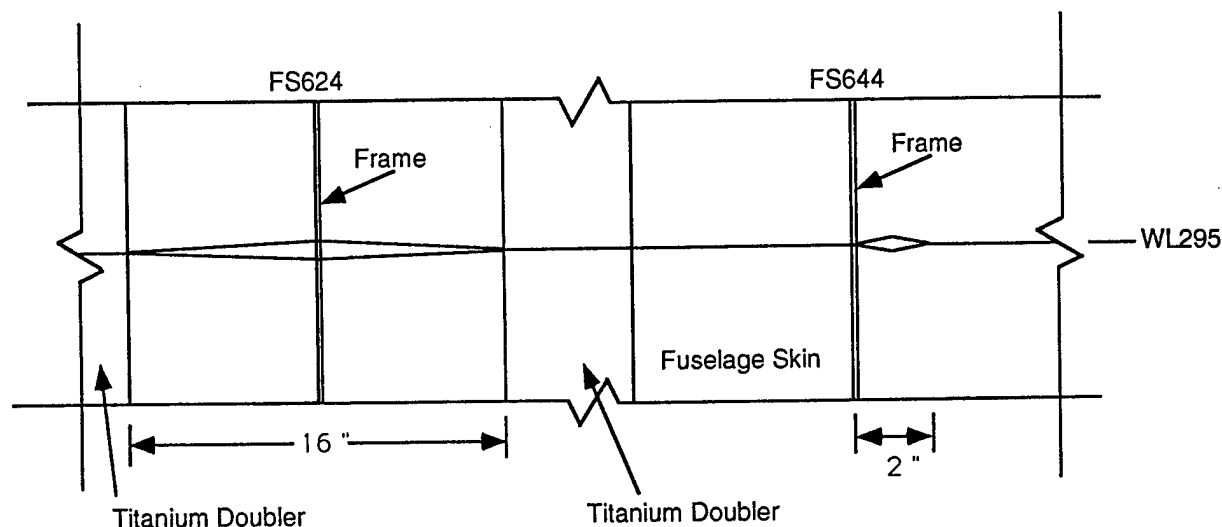
Figure 4: Cracks at WL 295; second crack pattern

Figure 4 shows the cracks along WL295 that were modeled to assess the effects of typical cracks on frames. Specifically, three cracks were modeled: one 16" crack along WL295 centered at FS624 was modeled to determine its effect on the frame at FS624; a 2" crack was modeled from FS644 to FS646 to obtain its effects on the frame at FS644; and one 0.15" crack was modeled at the fastener hole to determine the stresses in the fuselage skin ahead of the crack when a crack initiates and propagates from the fastener hole at an angle making 45 degrees with WL295.

**Internal pressure:** For the internal pressure load only, the maximum principal stress along WL295 rose from 19,110 psi to 19,700 psi; the stresses at the aft end of the hole along WL295 dropped from 19,080 psi to 16,130 psi. Table 3 shows the forces in the frames under various conditions. Note that a 16" crack increases the bending moment in the FS624 frame at WL295 from 7,503 in-lb to 22,777 in-lb, or 204%. The axial force increases from 5,350 lb to 10,599 lb, or 98%. The 2" crack near the frame at FS644 increases the bending moment by 25% and the axial force by 5%.

**Internal pressure with cargo load:** The maximum principal stress at the fore edge of the fastener hole, for this load case, rose from 20,380 psi to 20,540 psi; the principal stress at the aft edge dropped from 19,860 psi to 19,180, however. Table 3 shows the forces in the frames when the cargo load is present. A 16" crack caused the bending moment in the FS624 frame at WL295 to increase from 4,893 in-lb to

19,396 in-lb, or 296%. The axial force increased from 5,618 lb to 10,688 lb, or 90%. The forces in the FS644 frame did not change significantly, however.

So far, it appears that no simple solution exists for the correction of the skin cracking problem. Although most of the cracks occur along WL 295, it appears prudent to develop a repair that applies to all cracks or to develop a set of repairs covering all cracks. The current repair involves putting titanium doublers on both sides of the cracks. The drawback of this repair is that it requires more holes be made in the skin, thus creating the potential for more crack sites. Other possible repairs include unloading WL 295 fasteners by designing a new structure for supporting the external fairing and routing the loads down to the next lower stringer. Also, the cracks occurring at other stringers could be eliminated by putting doublers on the opposite side of the skin. These repairs will not address the corrosion damage that already exists in these areas. Another repair that addresses all of the concerns is a

Boron Epoxy patch. The current fasteners should be replaced with flush countersunk fasteners to remove some of the existing corrosion and provide a flat surface to bond a multiple layer Boron Epoxy patch. Such a patch will reduce the stresses at the crack tip and carry the load across the crack. Also, the patch would inhibit further crack growth, as well as crack growth from existing corrosion pits. Furthermore, since no new holes are required, new potential crack initiation sites would not be created. It appears that seven layers of Boron are needed in multiple directions to carry the hoop tension and longitudinal stresses from pressurization. An extension of the FEA work to investigate the Boron Epoxy repair is recommended.
